Notes: input buffer modification

Clee Quantizer input buffer modification

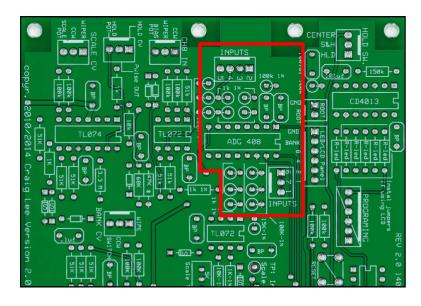
Replace this DG408 with DG408CJ+, this is the version with the lowest charge injection

If building a new Quantizer, don't install these 100K resistors and replace the 1K0 with jumper wire

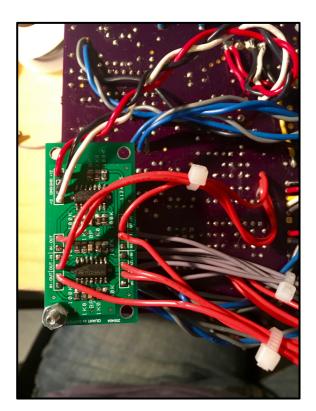
The buffer board is a small PCB with 7 unity gain buffers. Wire the connections from the panel jack to IN on the buffer board, and the buffer board OUT going to the inputs of the Quantizer PCB.

Connect inputs 1-7. Input 8 is already buffered by the processing input circuit

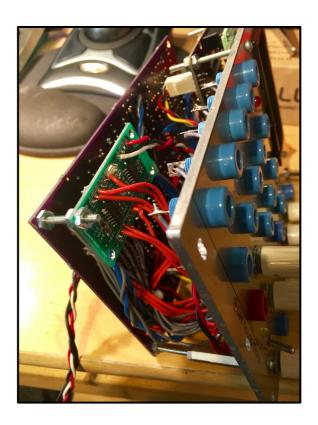
The red wires are the inputs to the Quantizer main board. The gray wires are from the front panel

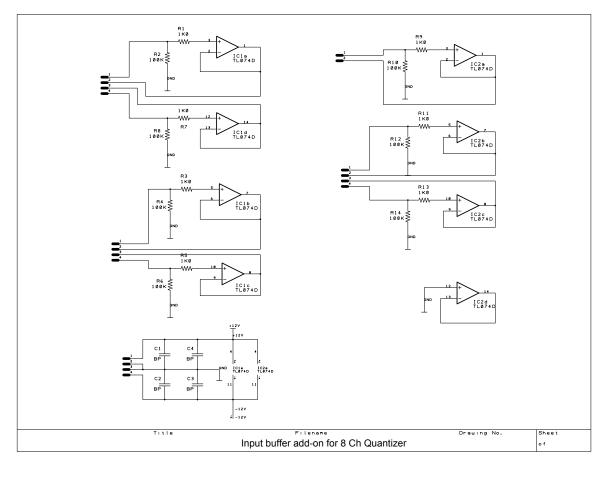
Input buffer PCB

This small PCB can be mounted to one corner of the main Quantizer PCB.

The panel input jacks should be connected to the pads marked IN, and the OUT pads should be connected to the Quantizer main PCB inputs

If you have a board without PIN 1 designated, PIN 1 is UP in this picture.
